PERATION

GREENHOUSE

SCIENTIFIC DIRECTOR'S REPORT

ANNEX 3.2 U. S. NAVY STRUCTURES

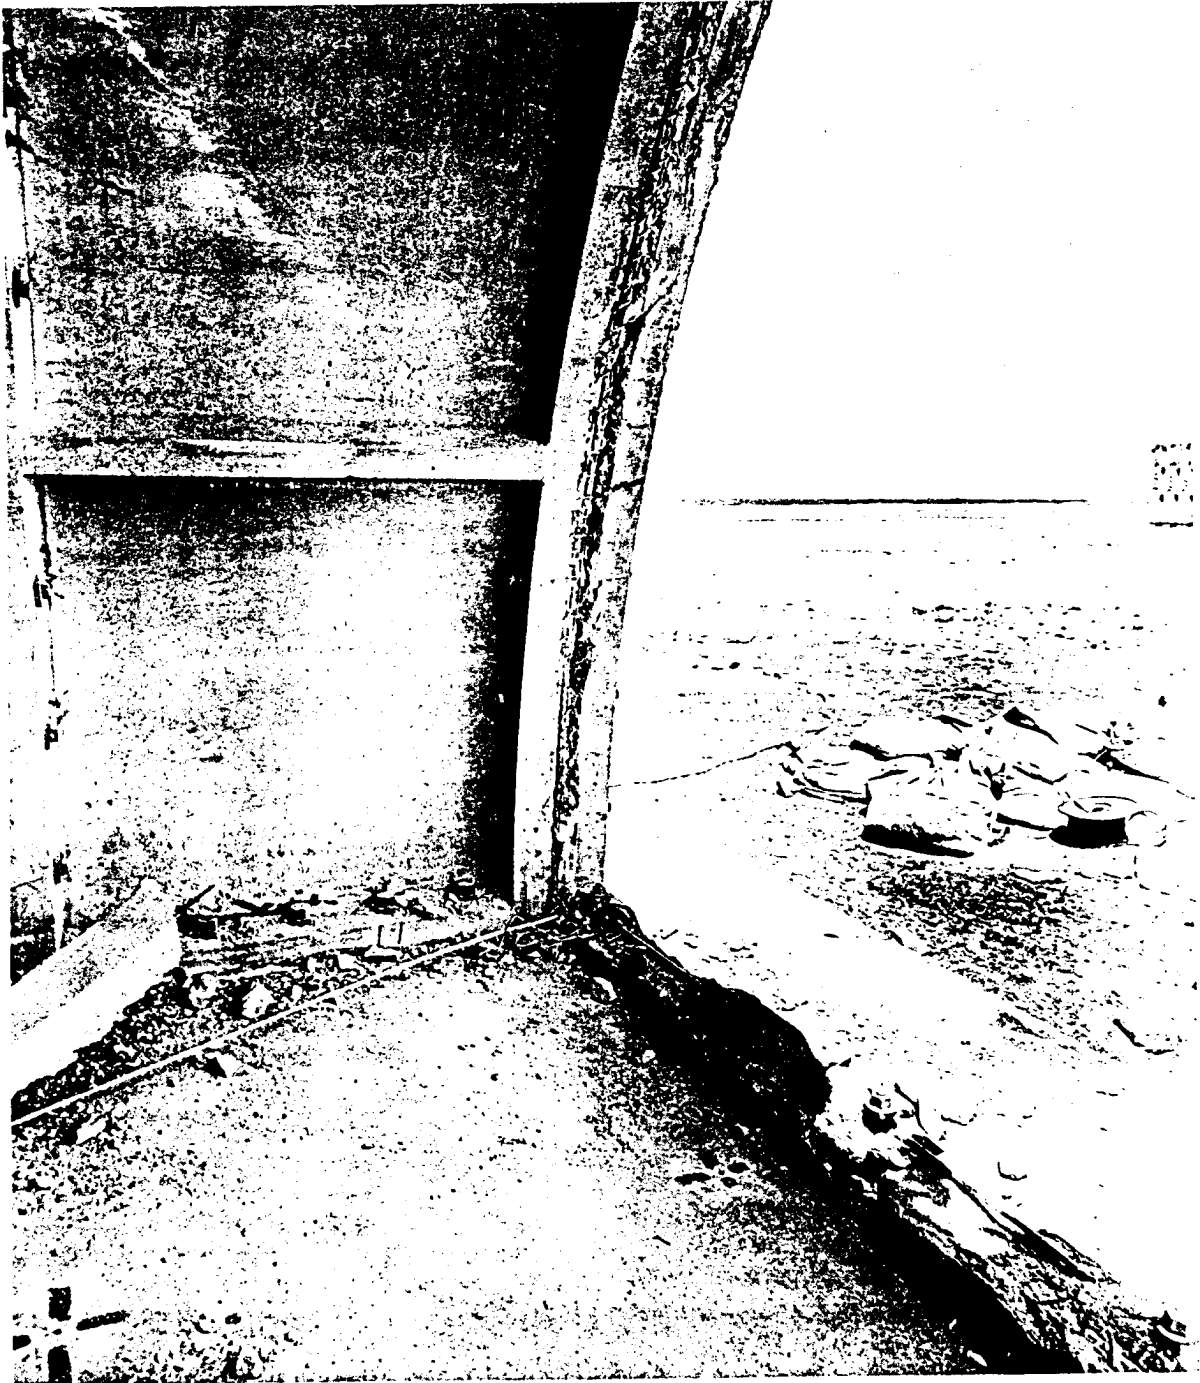
Fig. L. 426 Ribs of Rear Panel of Right End Wall in Place after Remainder of Panel Broke Loose at Junction of Skin and Rib, Structure 3.2.5

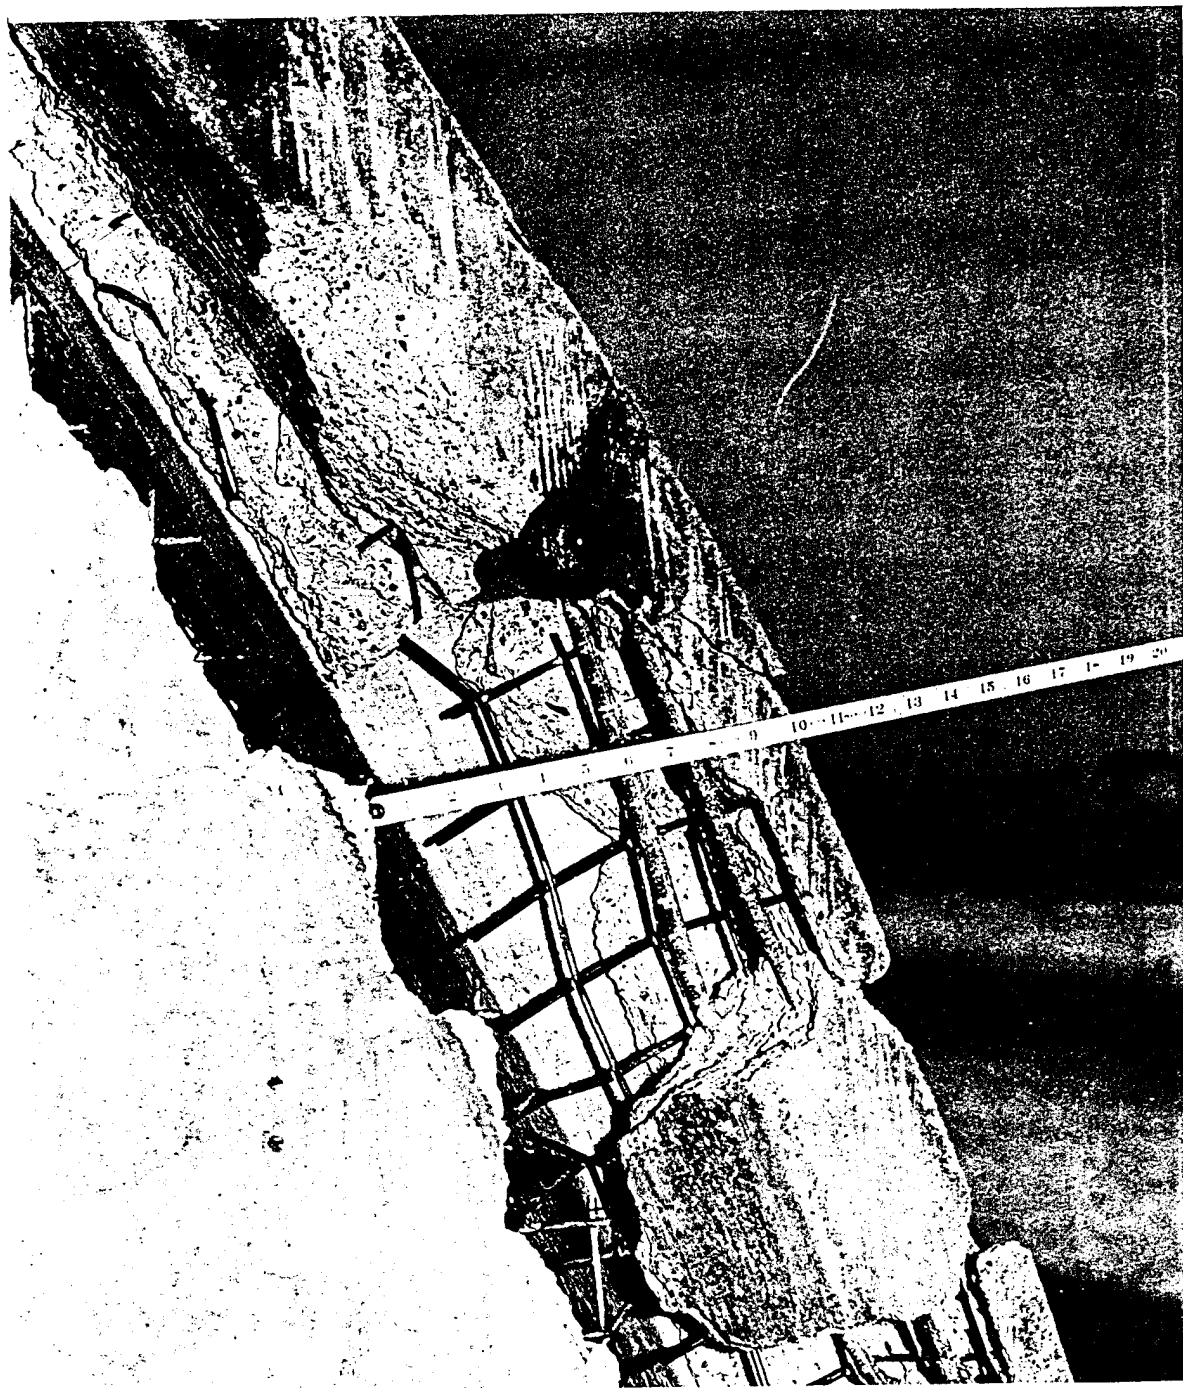
Fig. L. 429 Close-up of Mesh Tension Failure along Rib of Front Panel of Left End Wall, Structure 3.2.5

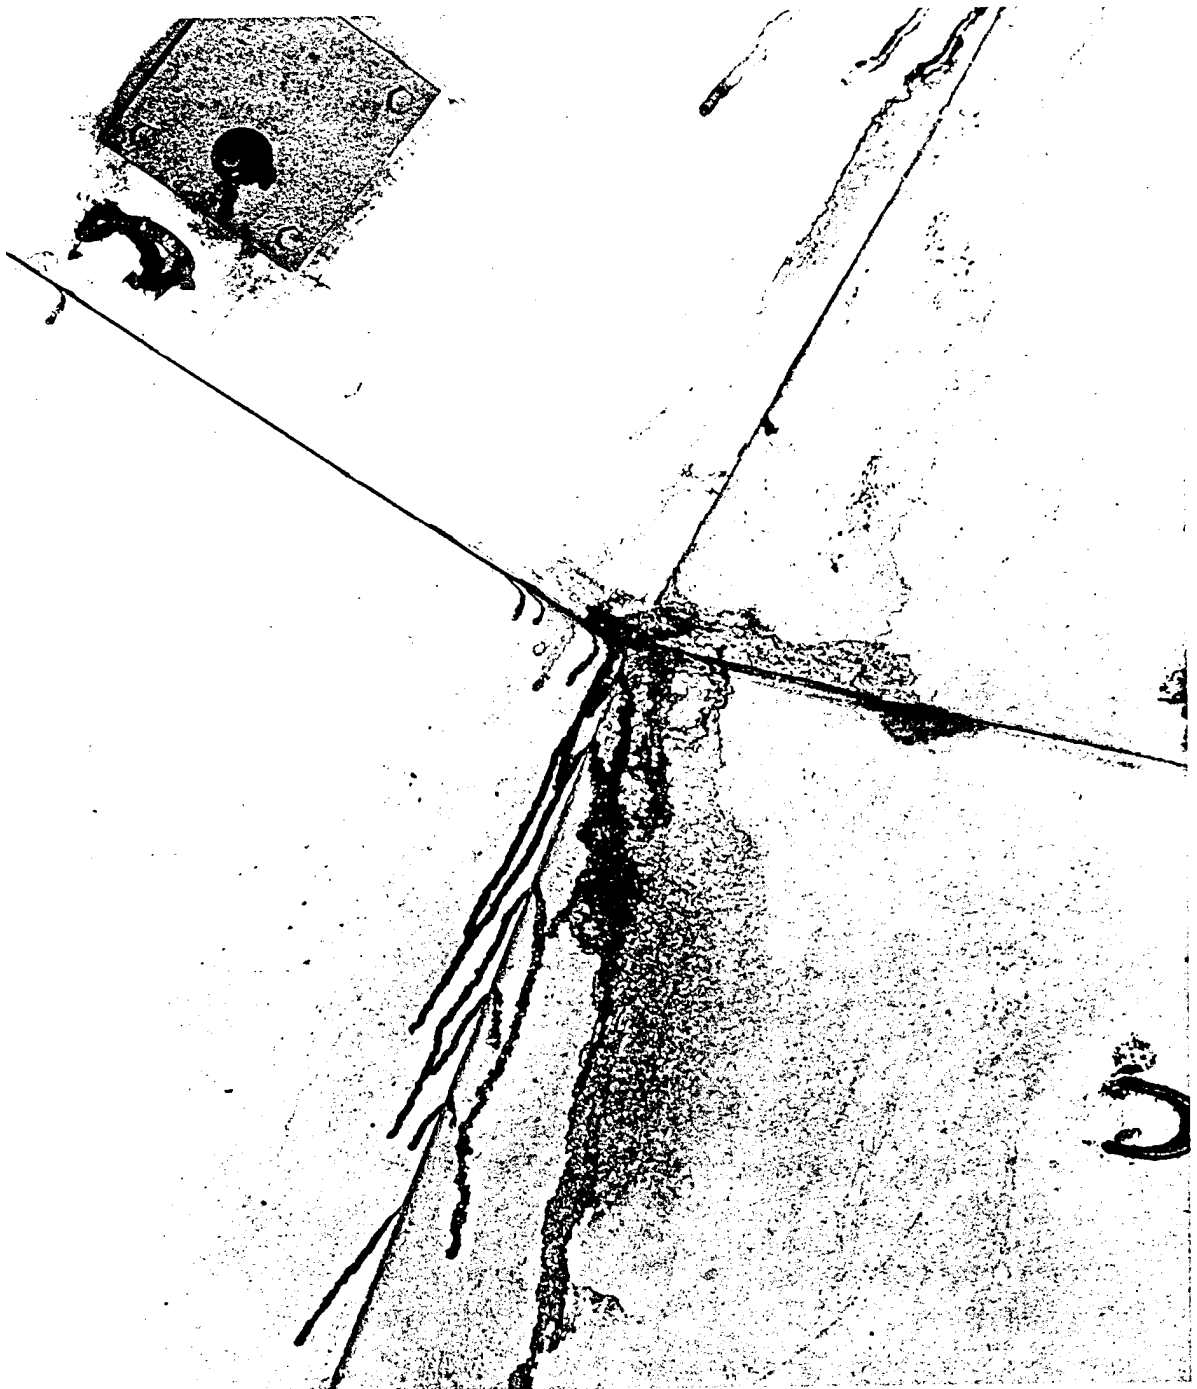
Fig. L.455 Spall at Corner Intersection of B and A Ring Panels near Front, Structure 3.2.6

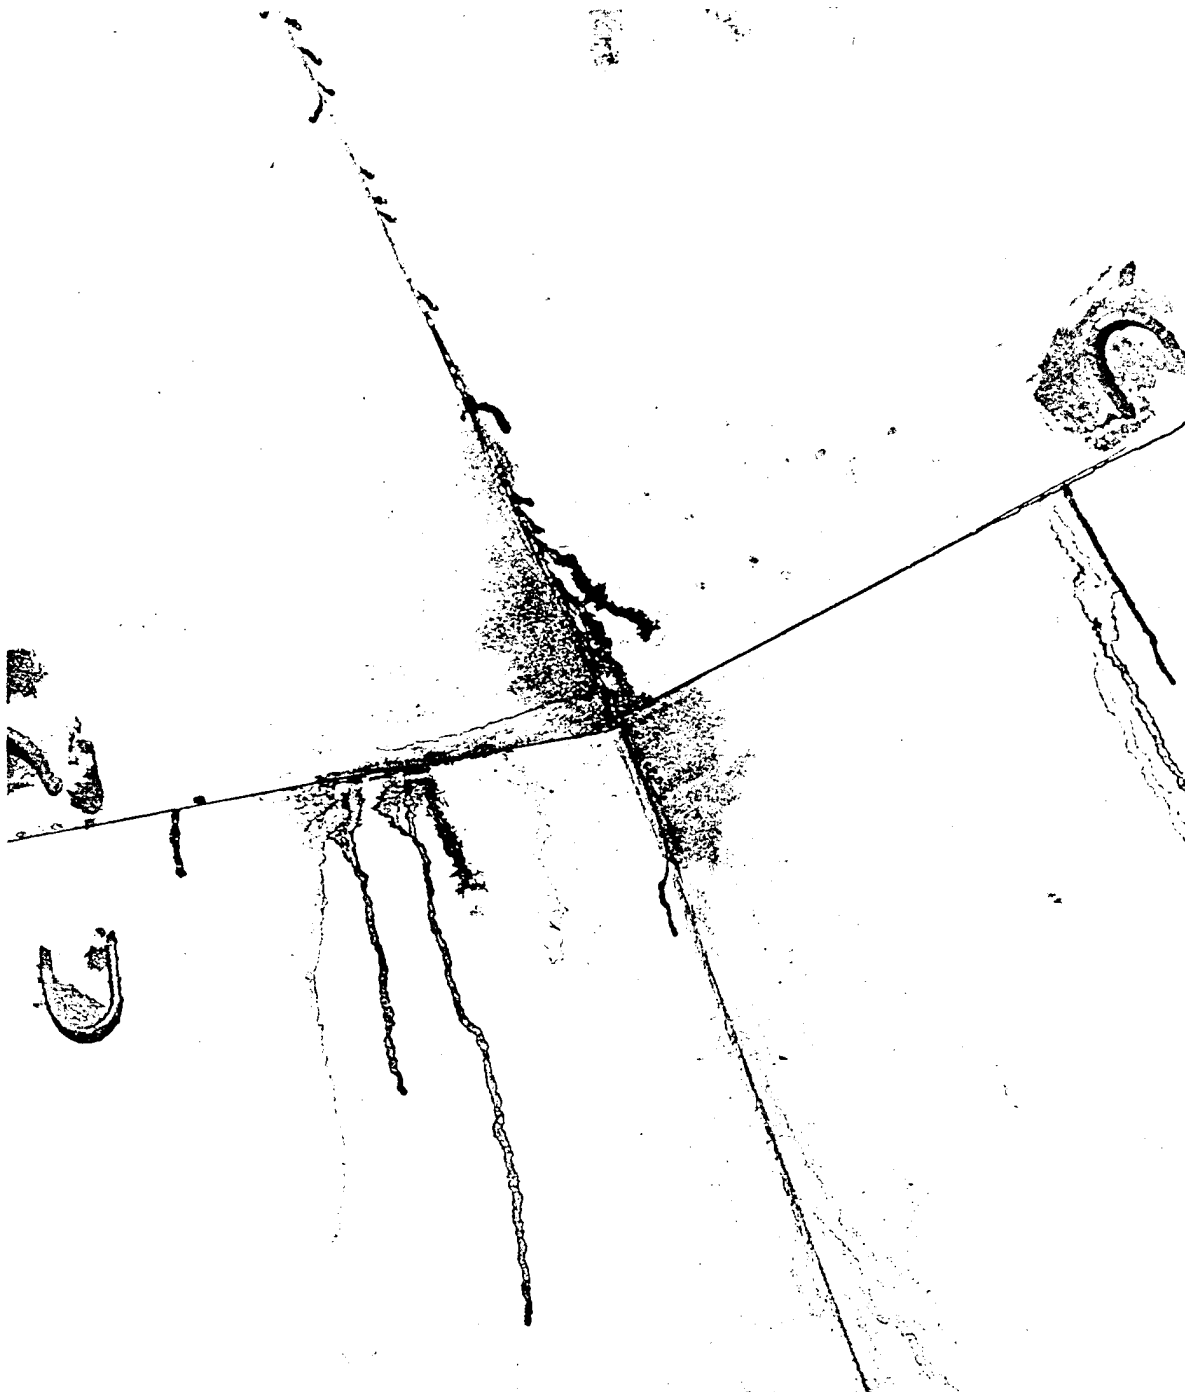
Fig. L. 456 Horizontal Crack at Corner Intersection of B and A Panels, Structure 3.2.6

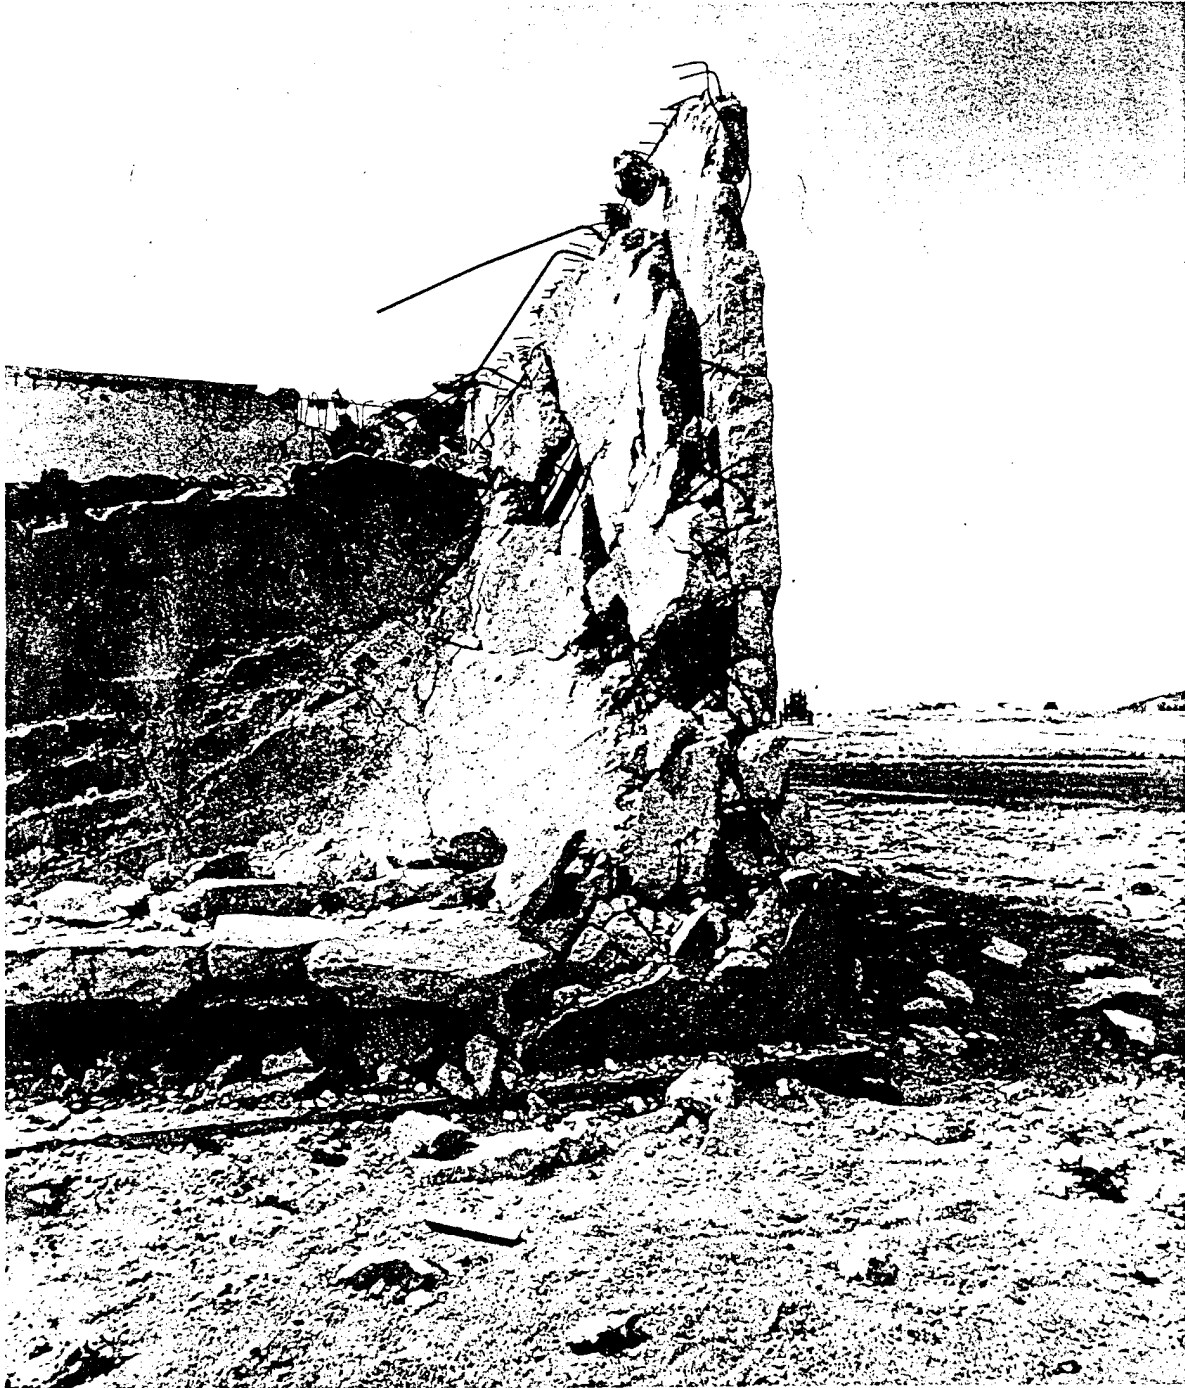
Fig. L.466 Right Front-corner Failure, Structure 3.2.7a

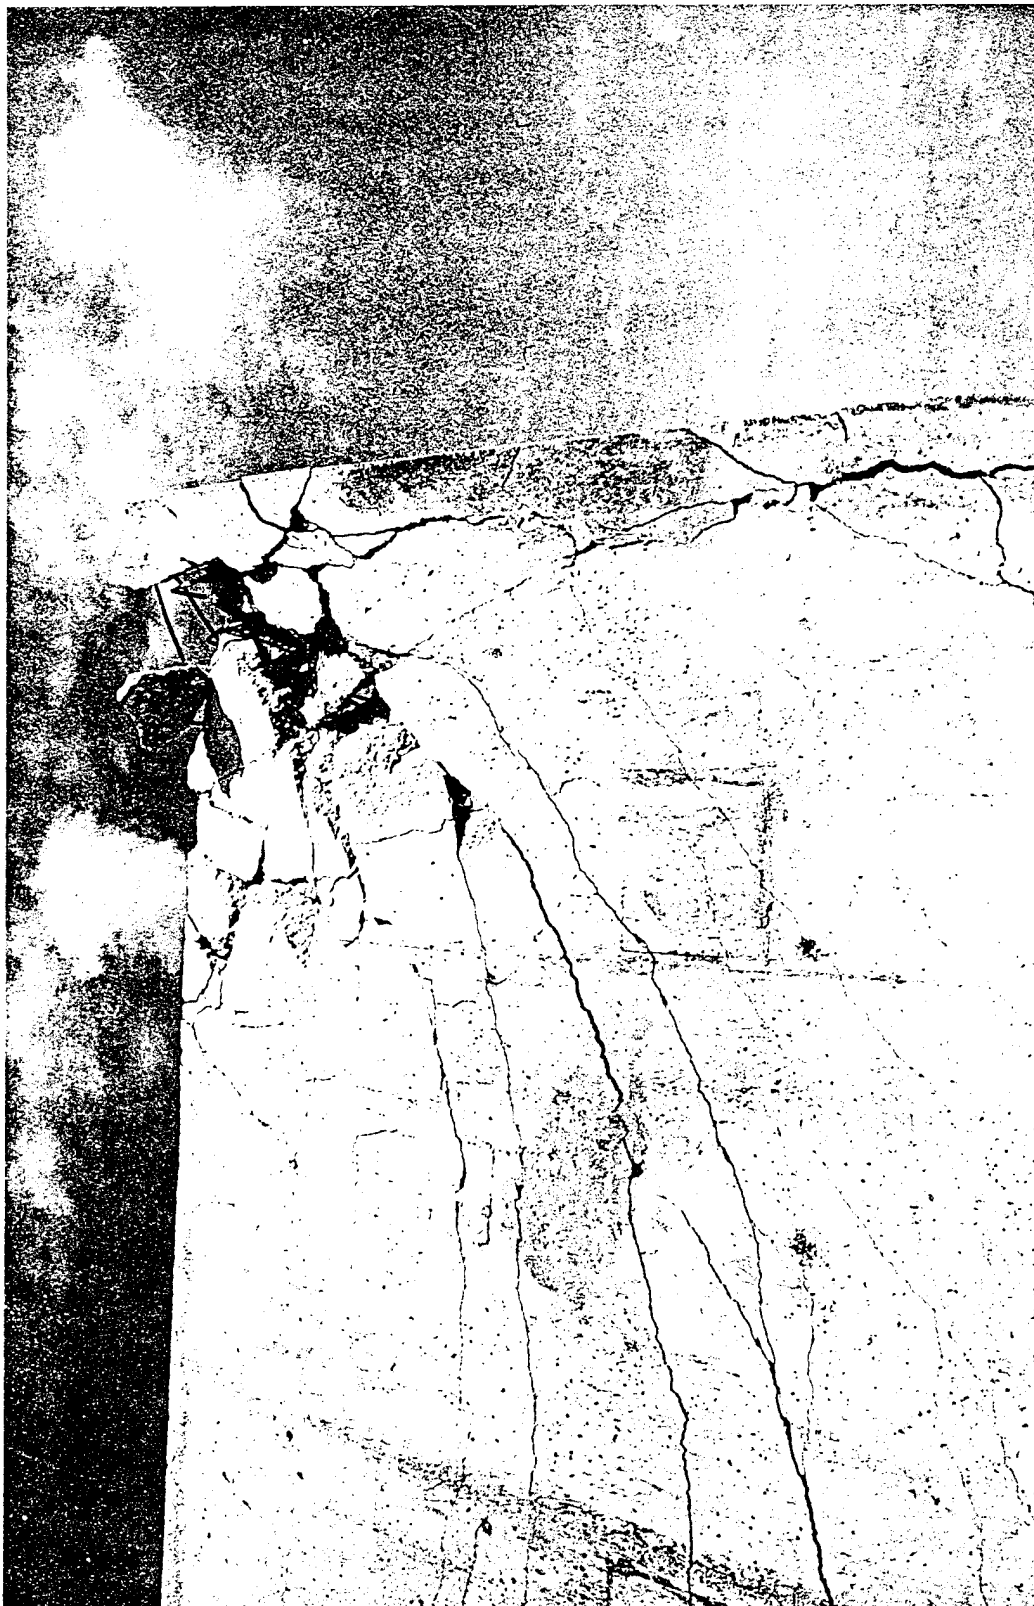
Fig. L. 474 Left Rear-corner Failure at the Roof Line, Structure 3.2.7a

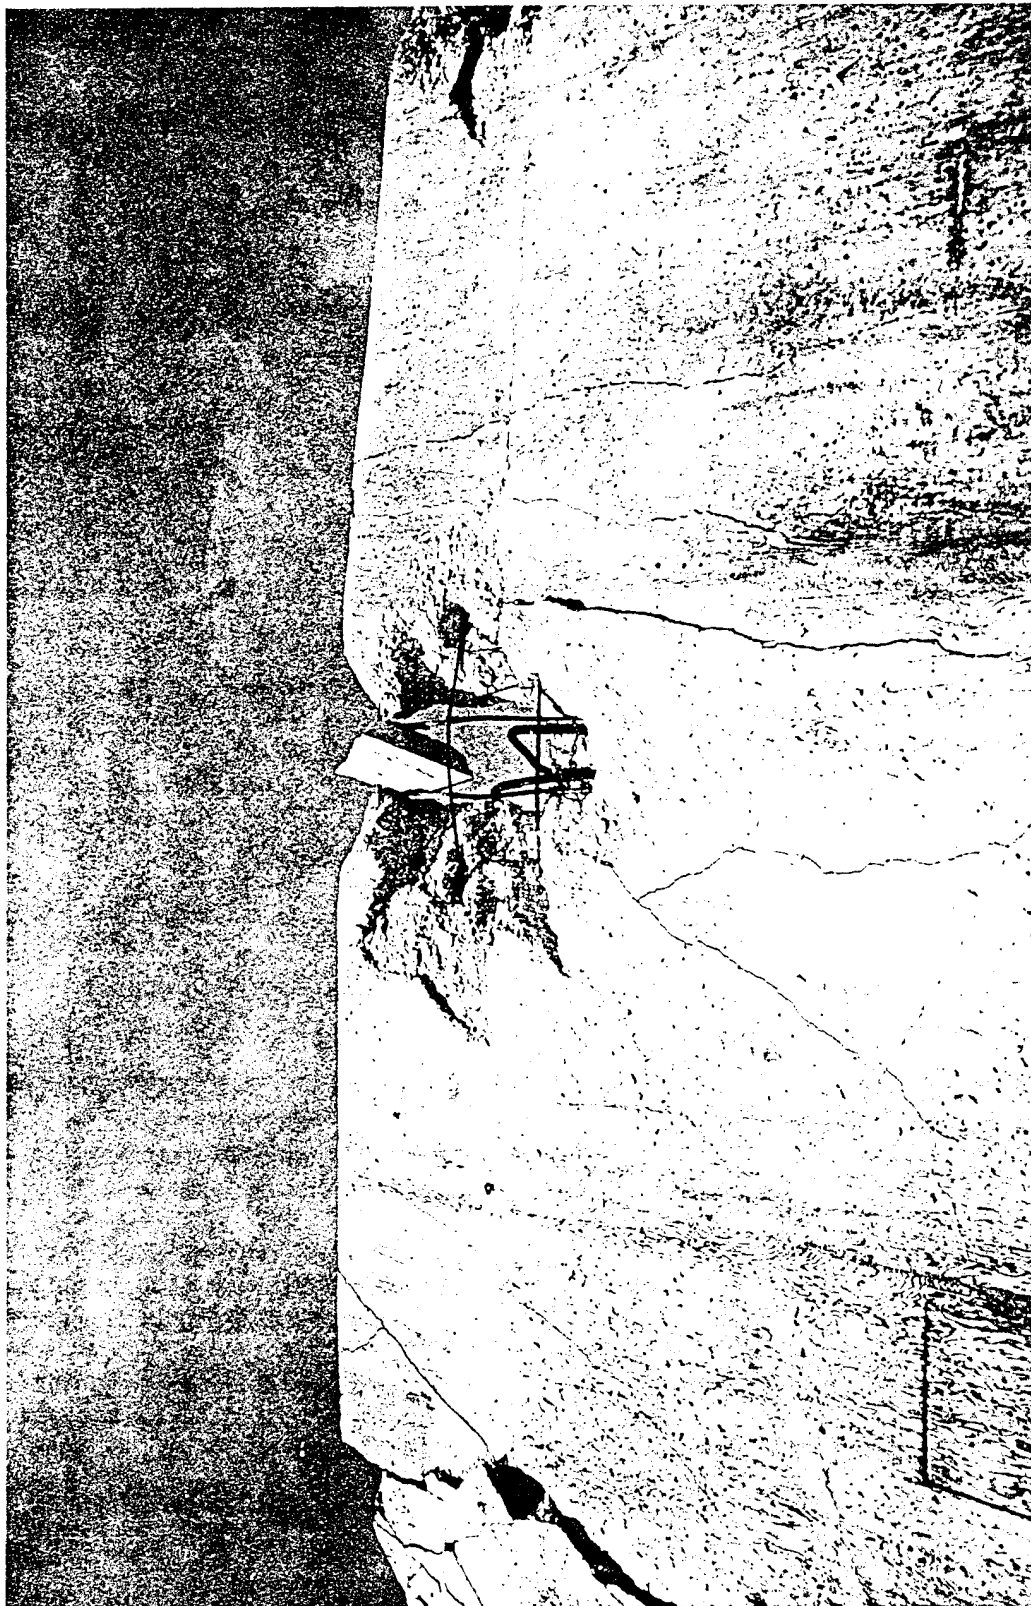
Fig. L. 478 Detail View of Failure when Stringer Haunches Pulled Away, Structure 3.2. 7a

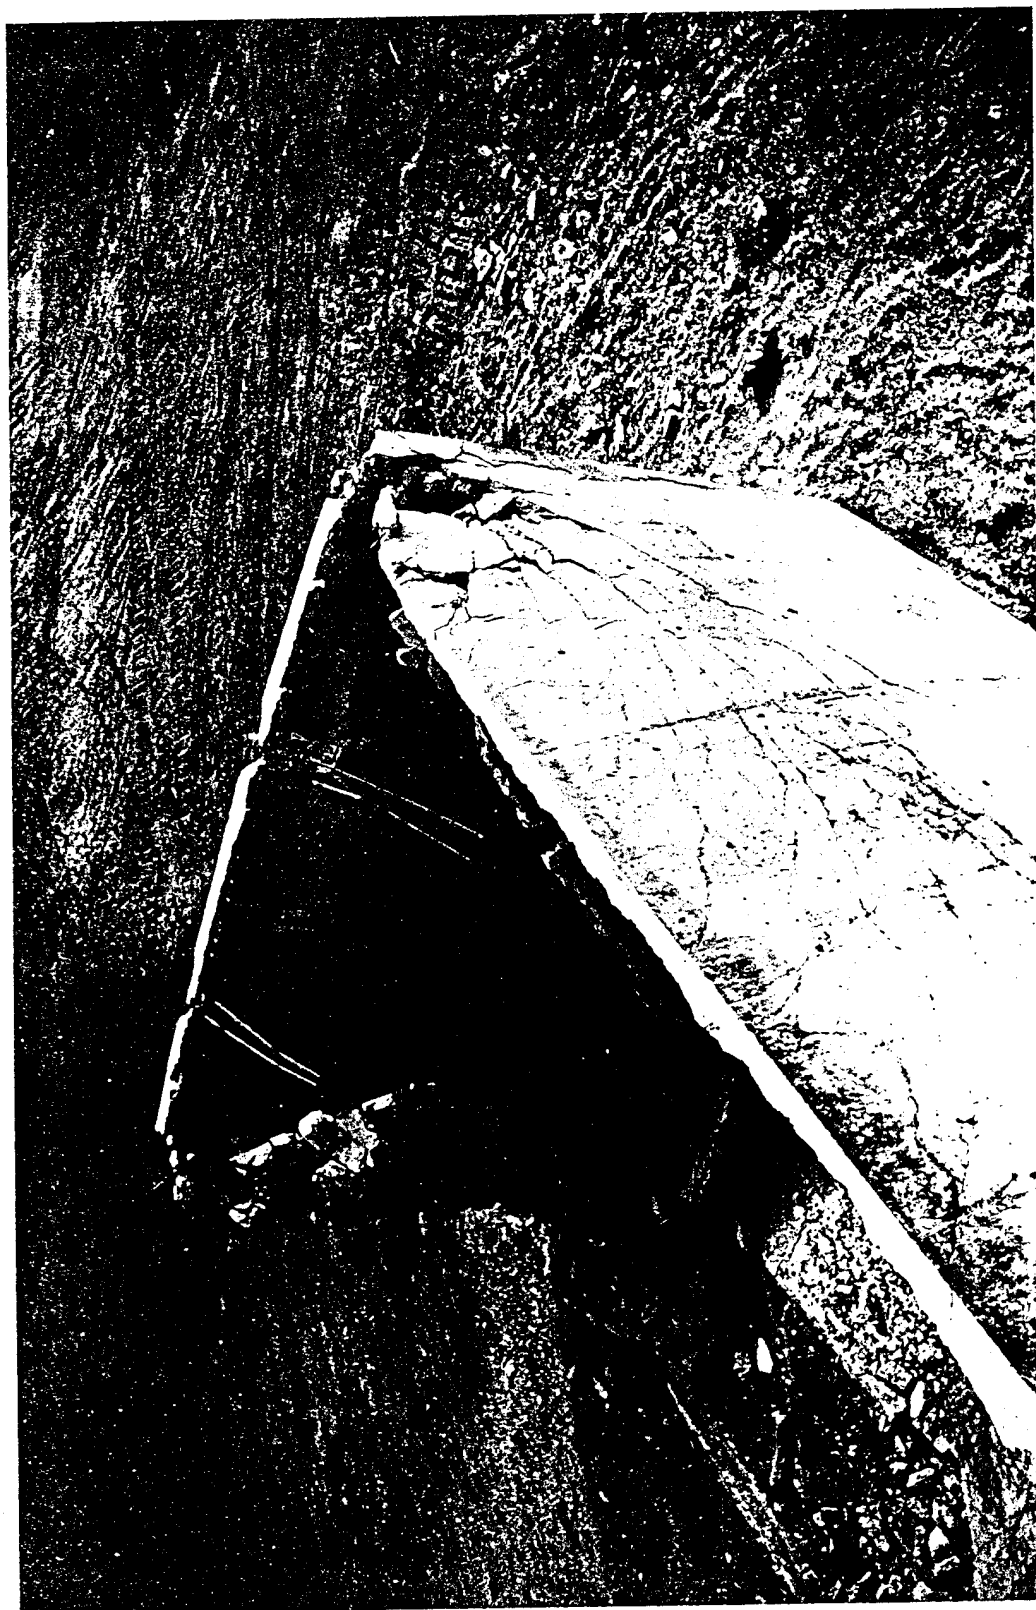
Fig. L. 479 Interior View of Left End Wall, Structure 3.2. 7a. Note stringer top tension steel remained with end wall.

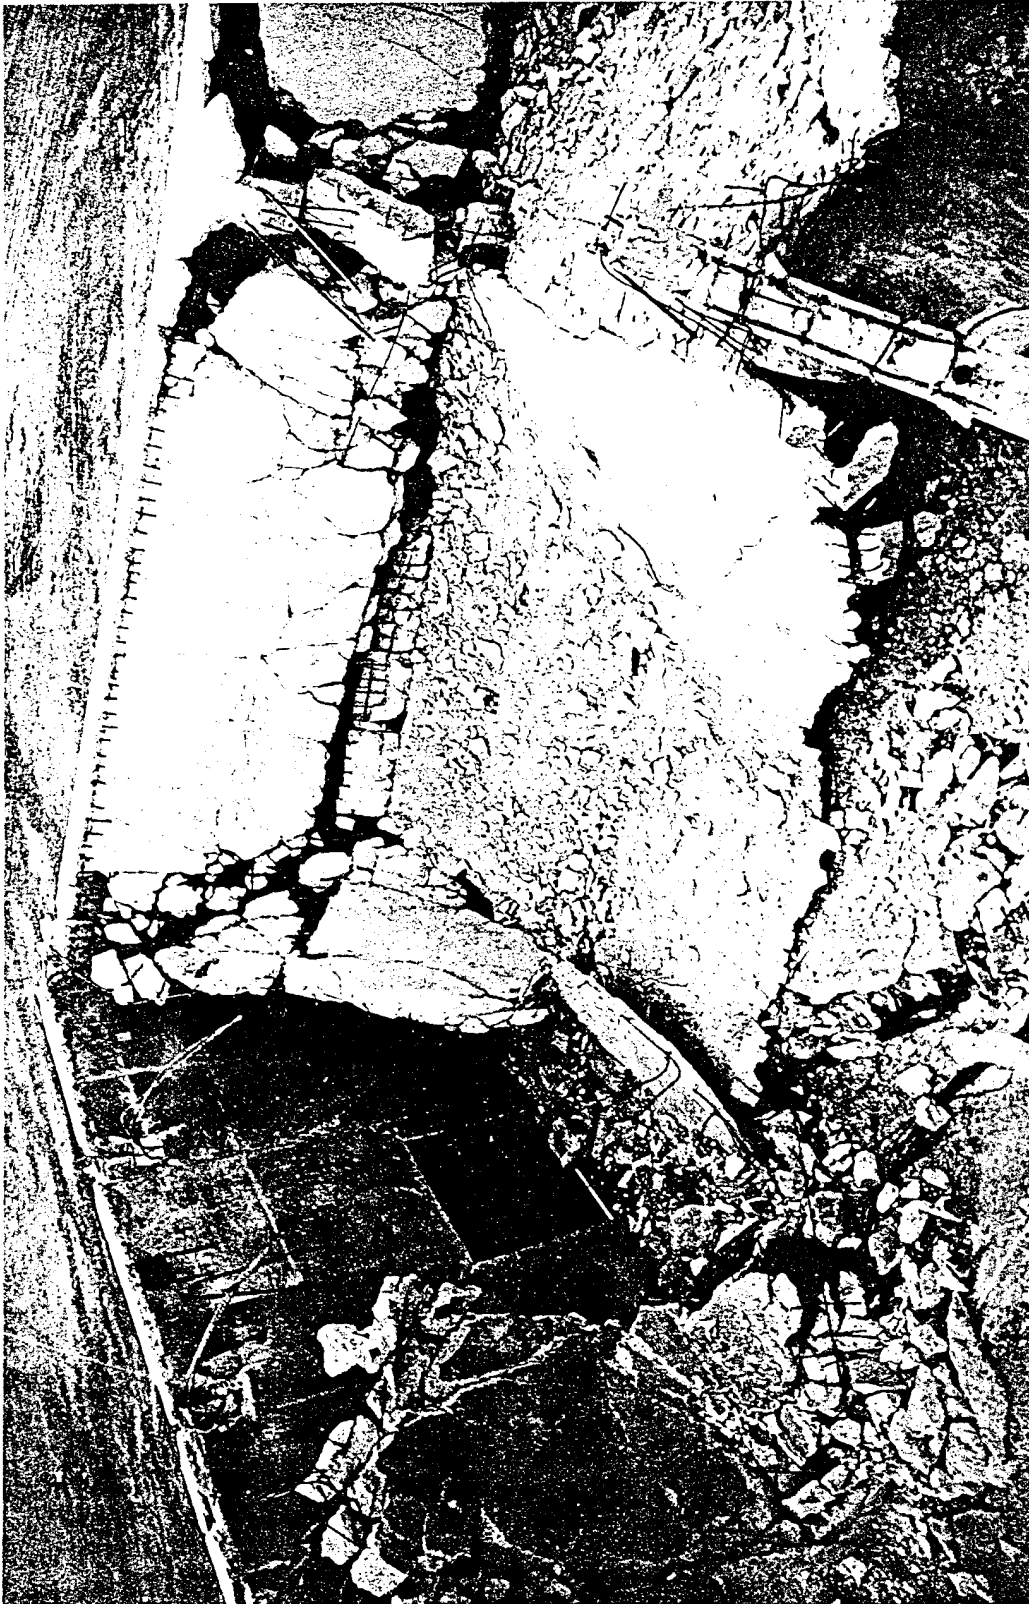
Fig. L.480 Failure of Left Half of Roof, Structure 3.2.7a

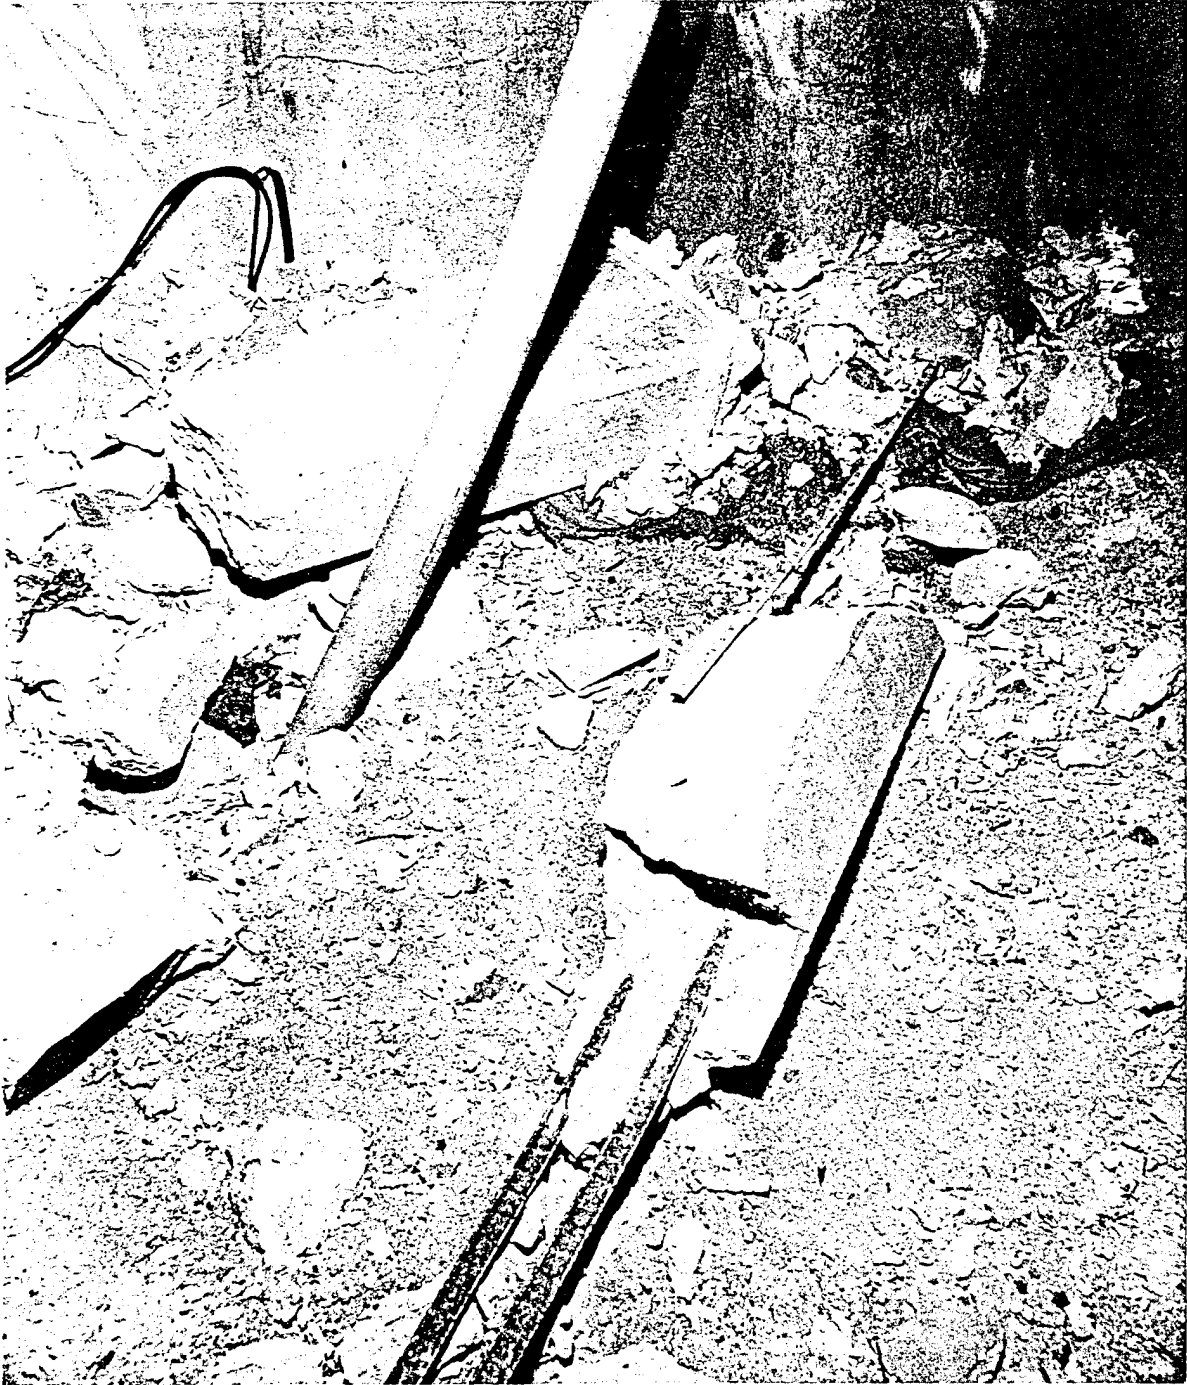
Fig. L.486 Untied Bottom Tension Steel of Stringers Dropped Free on Initial Loading, Structure 3.2.7a

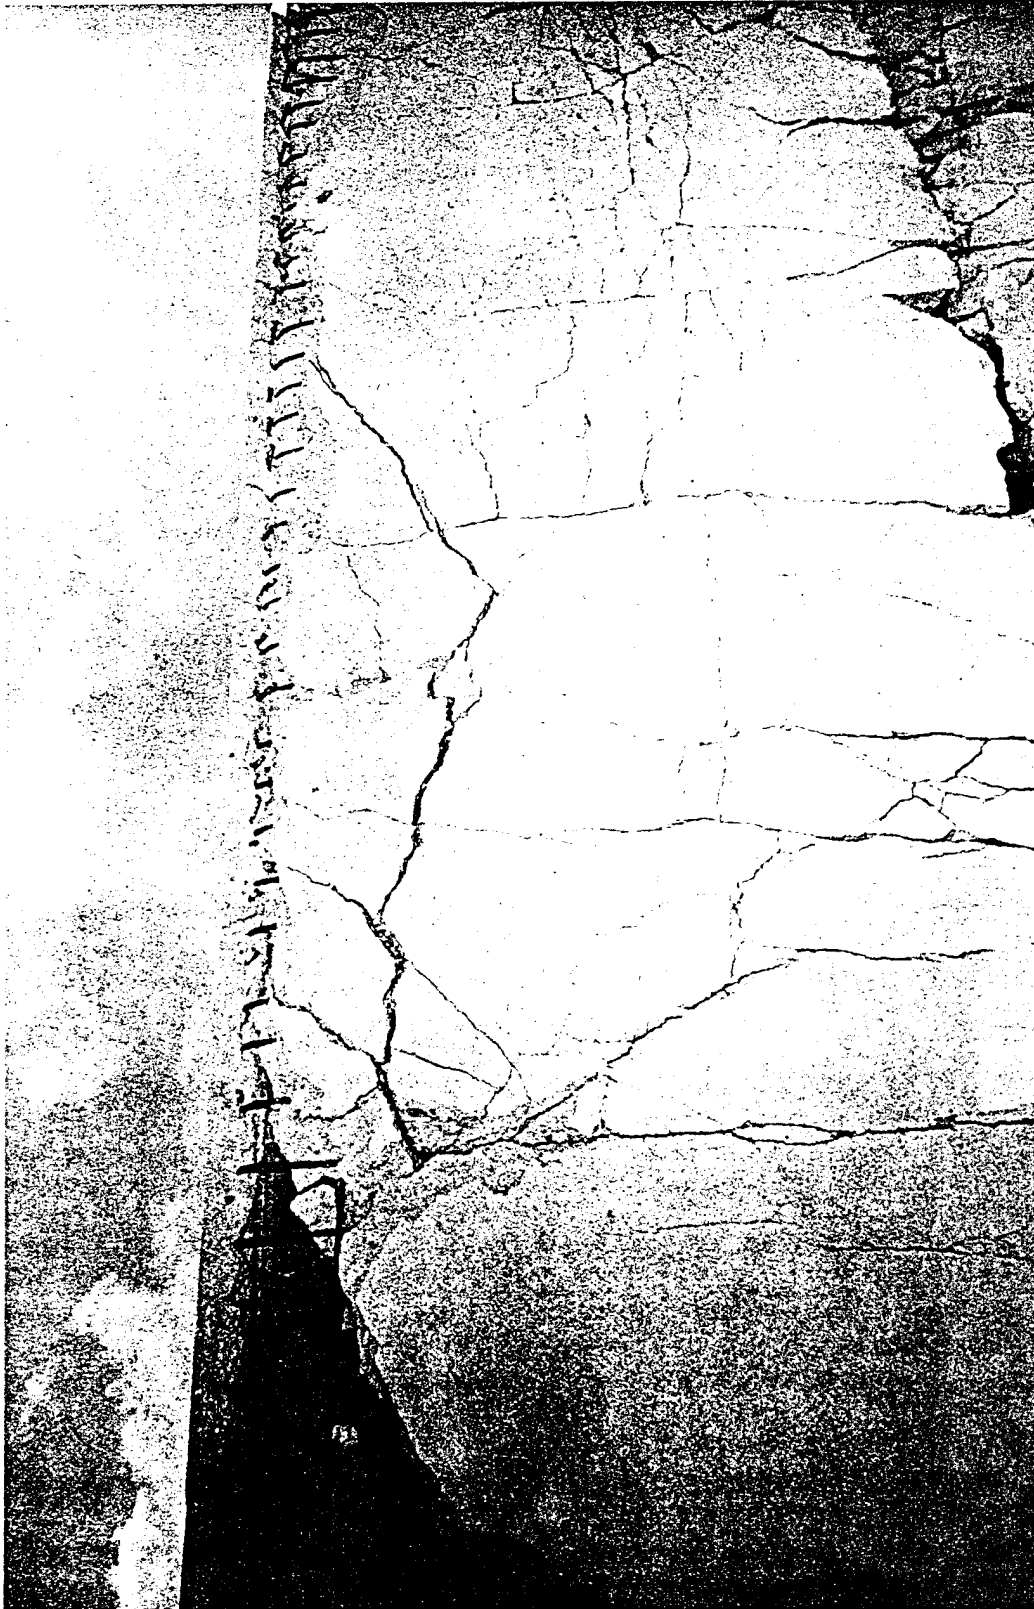
Fig. L. 490 Failure of Roof to Rear Wall, Structure 3.2.7a. Bar hooks held. At bottom right, failure of roof along the rear longitudinal string line is shown.

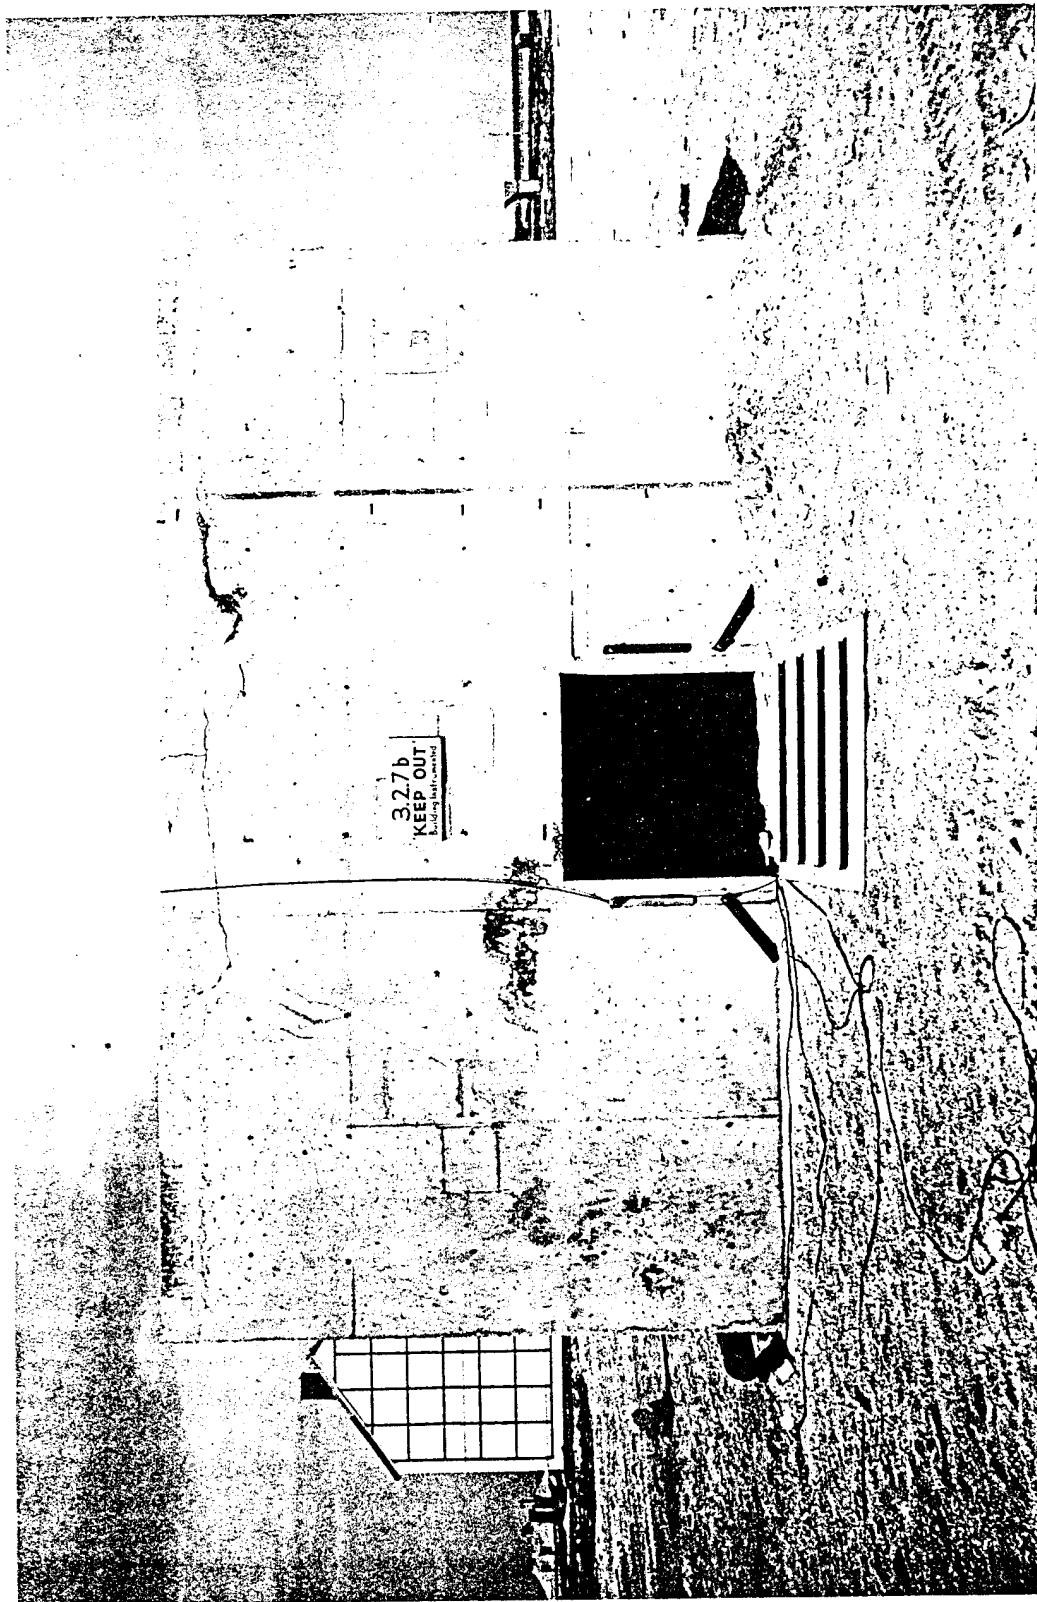
Fig. L. 501 Left End Wall after Blast, Structure 3.2. 7b. Door has been removed by hand; it suffered no damage and remained in place.

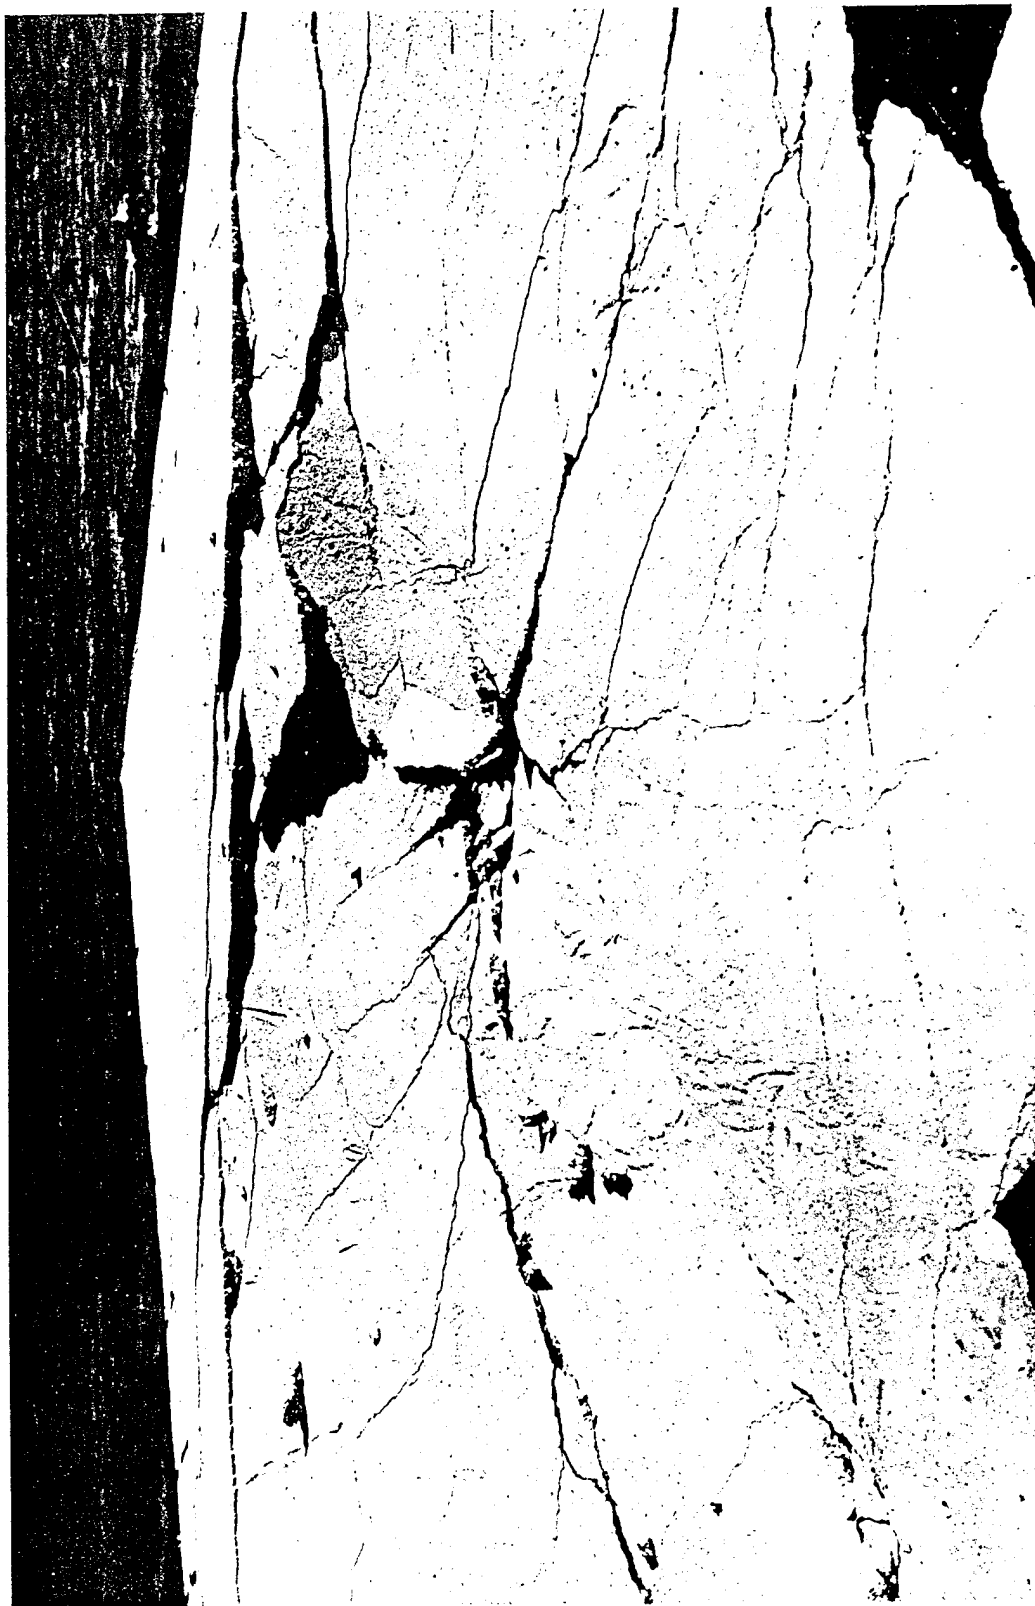
Fig. L. 507 Cracks and Fractures in Roof Slab at Front Corner, Structure 3. 2. 7b
